## MARINE INVESTIGATION REPORT

M04L0066

### CAPSIZING

INFLATABLE RIVER RAFT

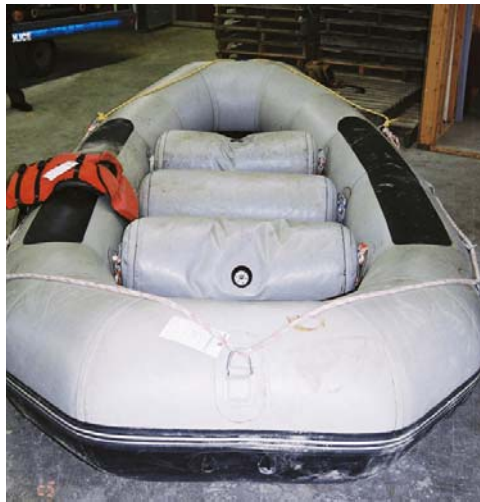
**Photo 1.** Front view of raft

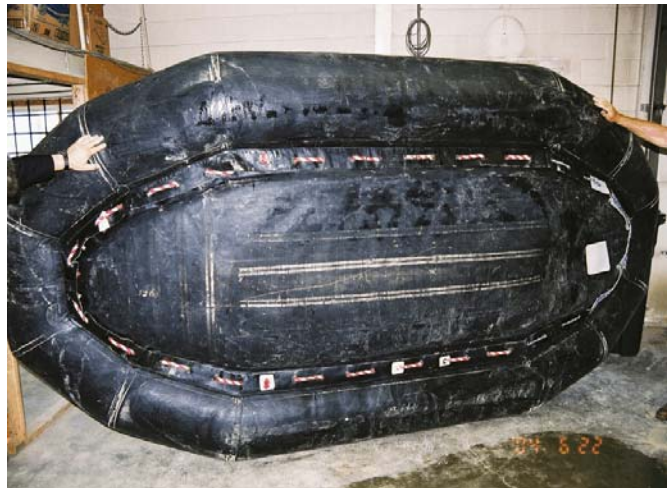
**Photo 2.** View of underside of raft

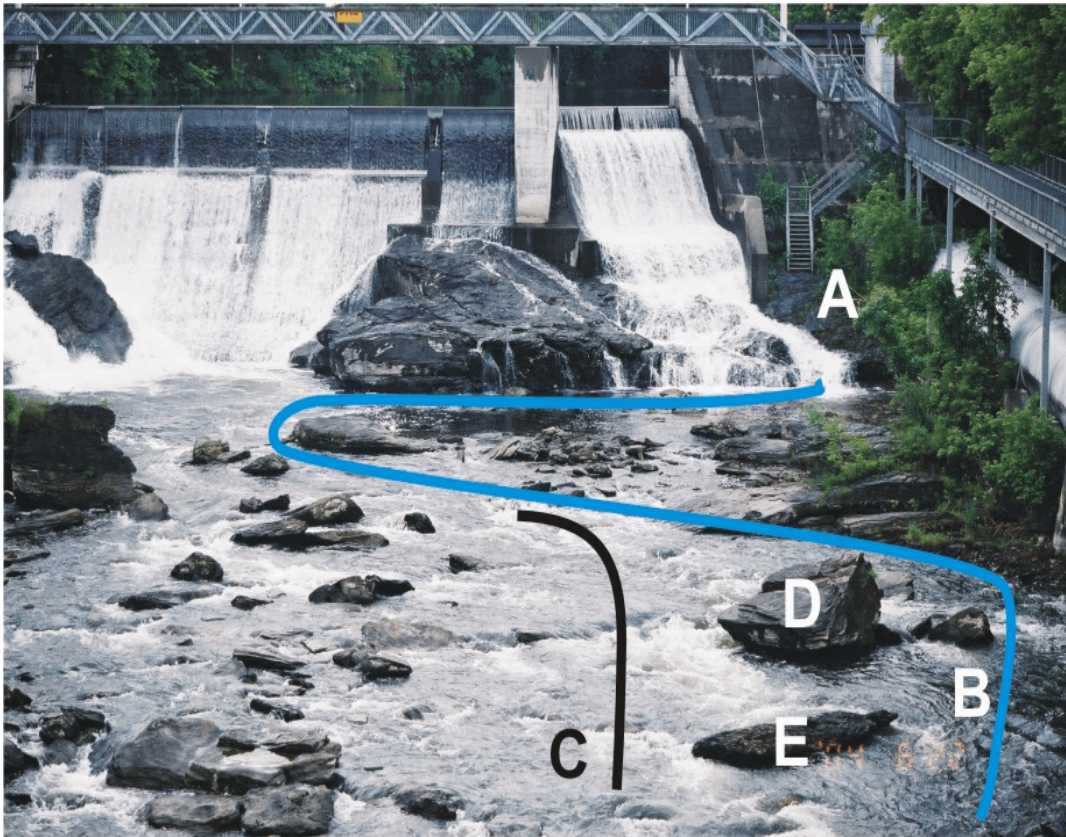
**Photo 3.** Abénakis Dam in background. The main route from point A to point B shows the descent taken on 11 June 2004. The secondary route to point C shows the route taken on the 19 June 2004 descent. Point D is the rock struck by the raft. Point E is the rock under which the passenger was found. Photo taken on 22 June 2004.

When the raft capsized, the force of the current most definitely led the body toward and held it under a rock (see photo 3, point E). After death, the passenger's body went into a state of hypotonia, that is, low muscular tension. The constant pressure of the current on the body of the unconscious passenger resulted in the victim losing his helmet and PFD.

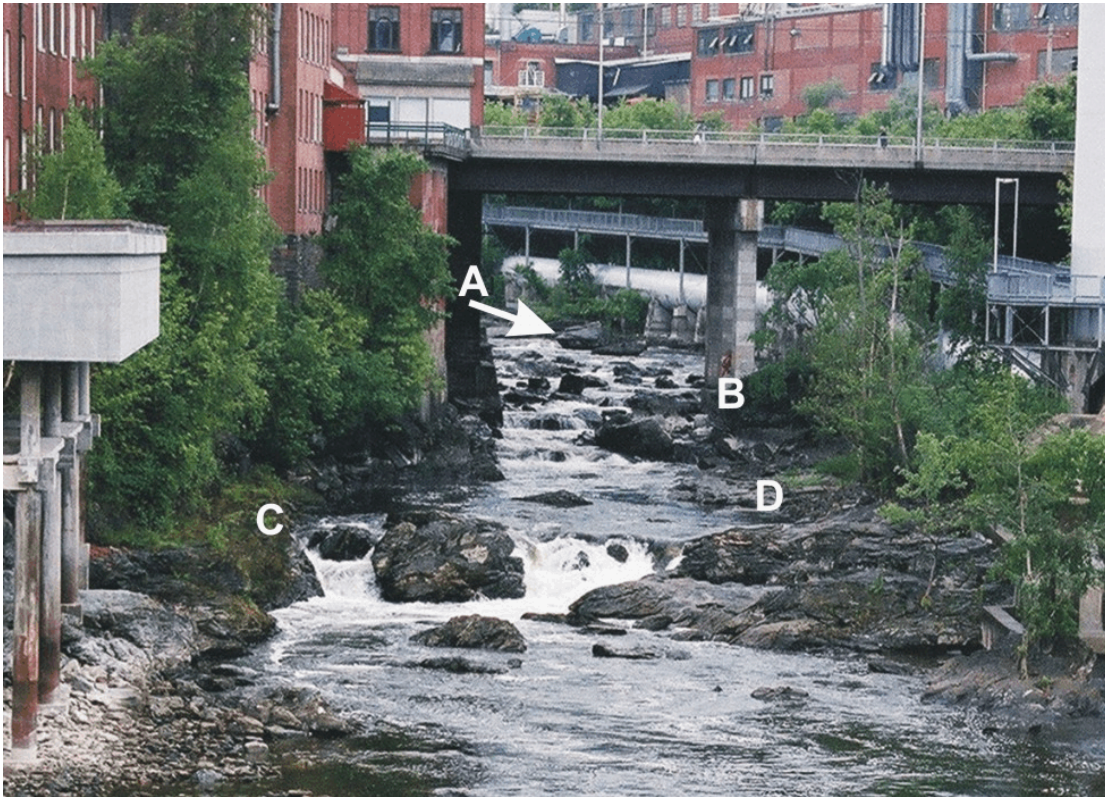
**Photo 4.** Drained Magog River (water level does not correspond to the level on 19 June 2004). Point A shows the rock where the capsizing occurred. Points B and C show the first and second ledge. Point D shows the location of the emergency team and kayaker.

On 19 June 2004, nine employees accompanied the company official. For operations to run smoothly, tasks were delegated to each staff member. One employee was in charge of equipment at Saint-François Park and another looked after the bus transportation of participants. Six guides looked after the rafts and passengers; two guides were responsible for the family component of the activity, while four guides were assigned to the whitewater descent. Lastly, the emergency team was composed of a kayaker and a guide with a bag of lifelines. The emergency team focussed its efforts from a site downstream from the first large ledge (see Photo 4).
